Subject: Tate & Lyle v. M/V Leon I, et al.

The following is in answer to inquiries between you and Attorney Robert Clyne, about the accumulated pitting, corrosion and abraded surfaces noted on the wires in the luffing wire (boom hoist rope) on Crane 4 aboard the M/V Leon I, involved in the accident of July 29, 2000.

Ref.: Wire Rope Evaluation
Tate & Lyle v. M/V Leon I
DOA July 29, 2000

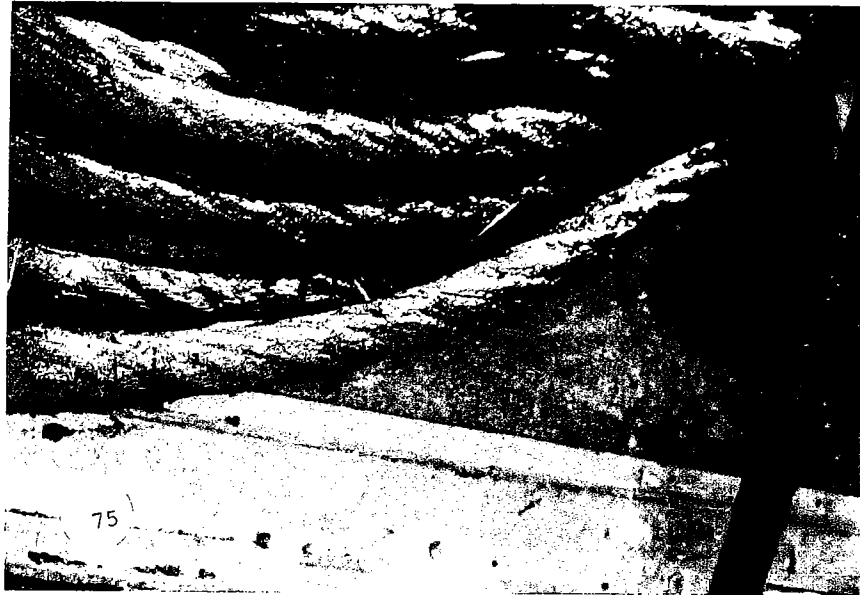
EC002697

It is obvious that the thick, grease/lubricant applied in the field only covered the outer surfaces and did not penetrate to the inner portions of the wire rope (Photograph EC 2728). This photograph, along with EC 002697, also confirms that the grease/lubricant was applied over a severely corroded wire rope in at least some areas. That is, in areas where the grease/lubricant is removed from the wire rope surface, highly corroded wires are exposed.
